Manhole Inspection Summary

Manhole # S39U__043MH

Insp Date: **2/20/09 12:38 PM**

Location Address: **764 BOYLE ST**

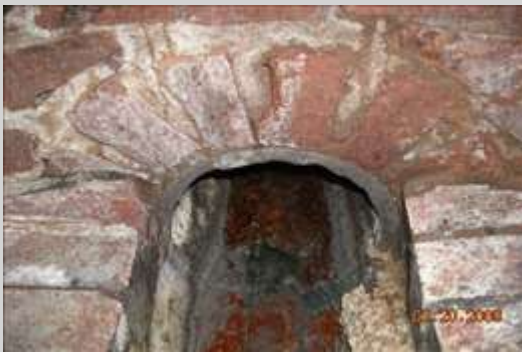
12 O'Clock Outflow

8 in. Circular Gravity Sewer
Pipe Out @ 12 O'Clock

Pipe Height: **8.4** (in.) Rod and Bar (Angled)
Pipe Material: **Clay** ☐ Pipe Lined
Invert Depth: **8.50** (ft.) Flow Characteristics: **Slow**
Deposits: ☒ None ☐ Mud ☐ Sludge ☐ Debris ☐ Grease
Silt Depth: **0** (in.) Deposits Extent:
Infiltration: **None** Pipe Seal Cond: **Sound**

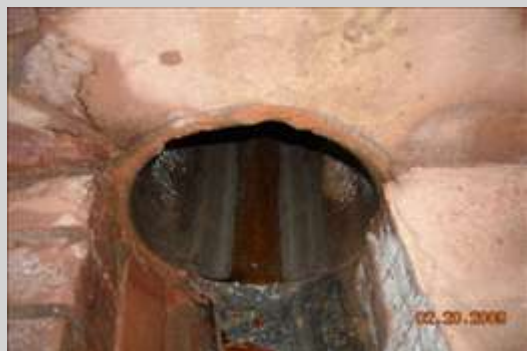
6 O'Clock Inflow

8 in. Circular Gravity Sewer
Pipe In @ 6 O'Clock

Pipe Height: **8.4** (in.) Rod and Bar (Angled)

Infiltration: **None** Pipe Seal Cond: **Sound**
